AirBorne Microlight /Trike Wing Nose Channel Airworthiness Directive

Part 1: Date 21st November 2003: We are currently investigating cracking in the area of the stainless steel nose channel on some Airborne wings. Until we have fully investigated this issue, we recommend that owners/pilots of all Airborne microlight/trike wings inspect the nose channel before flying.

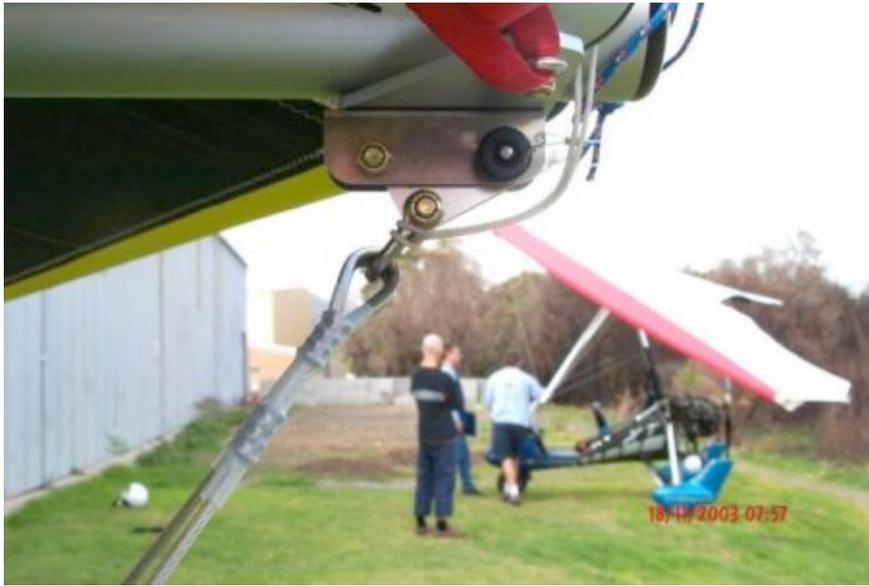
Stainless steel nose channel where front wires attach Note: the extra attachment on the photo is simply a string that holds identification tabs on new wings.

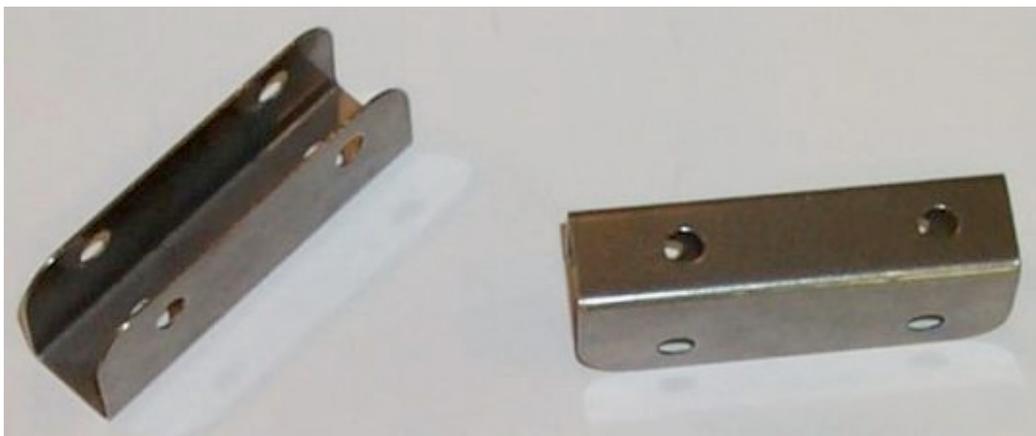
Two views of the stainless steel nose channel after removal from the wing

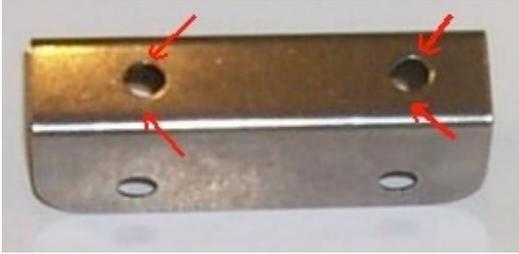
Back view nose channel

Once the nose channel has been removed check for any cracking around the holes on the back side where the channel attaches to the wing. If any cracking is found do not fly the wing until the part has been replaced.

Part 2: Date 25th November 2003: Our engineers have been studying the reports of cracking that we have received. Analysis and tests have confirmed that this cracking is caused by fatigue due to local stress concentration in the region adjacent to the front mounting bolt. We have simulated, by test, the complete failure of the nose catch in this region. This testing shows that, even if the front bolt hole failed, the rear bolt and the nose catch channel alone are capable of supporting a load of at least 8g.

Carefully inspect the holes on the back side of the nose channel for cracking around the holes themselves.

In the meantime an inspection of the nose catch channel is essential and any cracking should render the aircraft unusable until such time as the part is replaced.

Part 3 and Final: Date 06th February 2004: We now have a 3 mm guage replacement nose channel available. We also have modified nose pip pins available. Regular inspection of existing nose channels by complete removal or replacement with the new 3mm guage channel is essential. The new channel will allow for easier nose pip pin assembly or removal, simply because of the heavier guage. Once the new channel is installed then inspection as per the maintenance manual is still required.

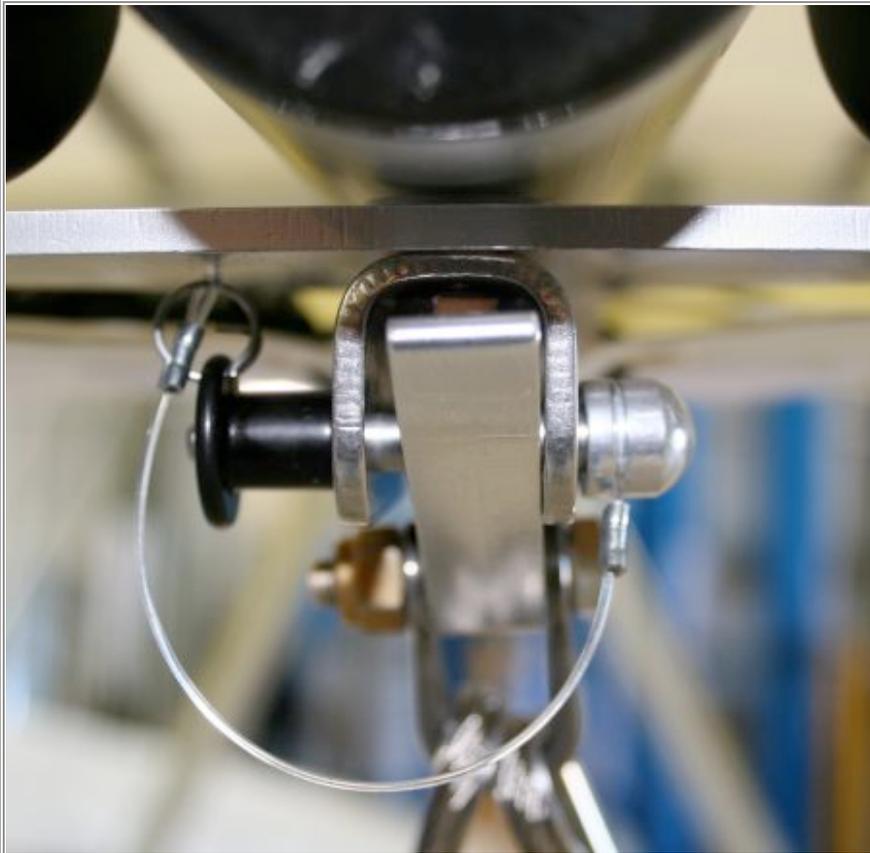
It is simple to check if your wing has the latest type of nose channel. See the picture below. The new nose channel is made from 3mm thick stainless steel as opposed to the old channel which was made from thinner 0.85mm thick stainless steel. You can use a rule to measure the thickness of your nose channel if you are unsure, or simply ask one of our dealers.
